**Flood Control Project Maintenance
Levee Inspections**

Fall 2019 Levee Maintenance Deficiency Summary Report

San Joaquin River Basin

Reclamation District No. 0404 Boggs

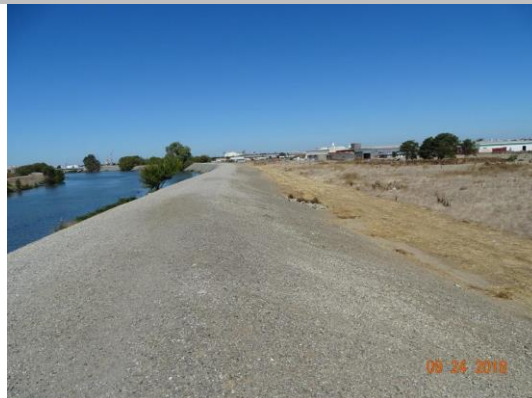
Photo 1 of 1 : FA_2019_RD0404_305_34_20191001_00055.jpg

Typical view of well maintained vegetation on landside slope. Fall 2019

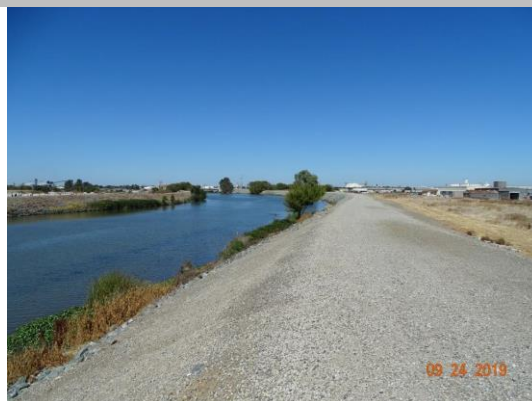
Photo 1 of 1 : FA_2019_RD0404_305_32_20191001_00056.jpg

Typical view of well maintained vegetation on waterside slope. Fall 2019

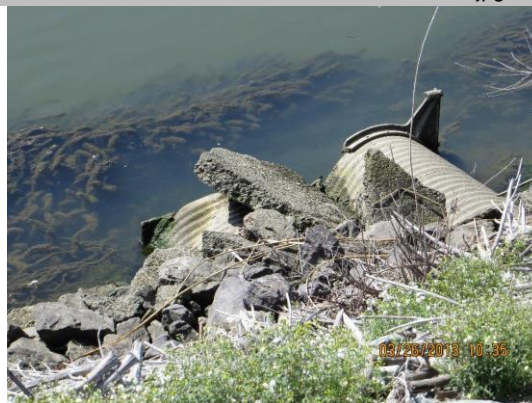
Photo 1 of 3 : UCIP_FA_2019_53346_20082.jpg

Comment Code						
Inspector Comment						
DS_ID:22968						
FS_ID:53346						
EP_NO: N/A						
Repair Type: Non-Urgent						
Crossing Status: Found						
UCIP Comments: 10/2/2018 Crossing shows no sign of pipe or levee integrity issues; down grading to Non-Urgent (D. Sanoski - DWR UCIP).11/29/2016 Flap gates still missing. Pipe open on WS. Could not locate on LS. (K. Fazel - UCIP)03/26/2013 Flap gate missing from WS toe. (P. Amatya - DWR)						
FIELD_STRUCT_DESC: 1 of 2: 36-inch corrugated metal gravity drainage pipe through the levee, approximately 18 feet below the crown. Pipe may not fully penetrate the levee as it does not daylight on the landside (LS). This drainage pipe was field discovered with no mention of it in any reference.						
FS Date: 10/2/2018 12:56:00 PM

WS- two CM pipes with damaged flap gates

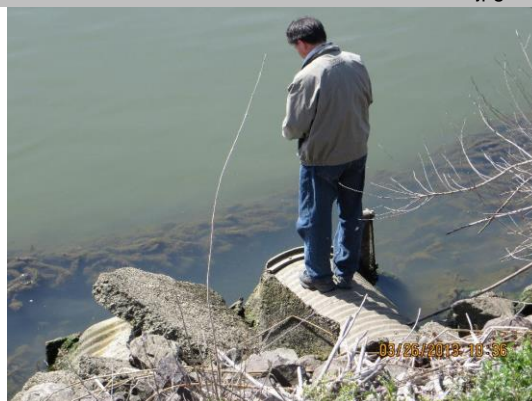
Photo 2 of 3 : UCIP_FA_2019_53346_20081.jpg

WS- left CM pipe with missing flap gate

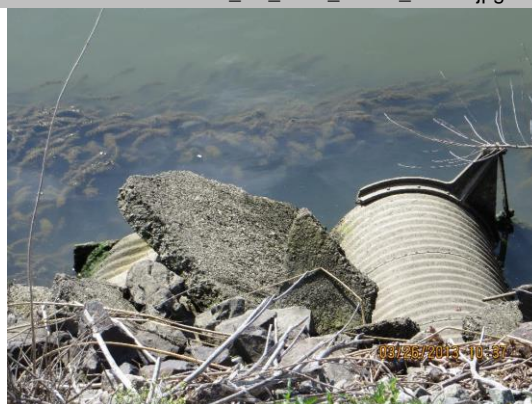
Photo 3 of 3 : UCIP_FA_2019_53346_20080.jpg

WS- closer look at left CM pipe with missing flap gate

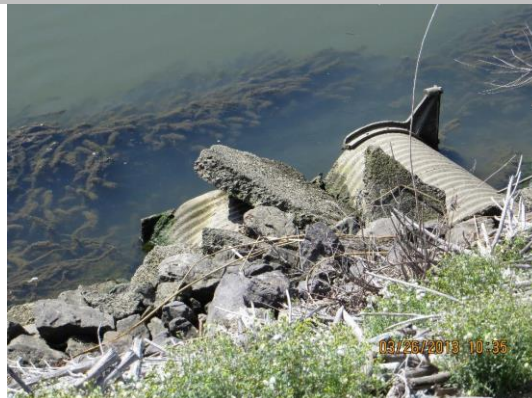
Photo 1 of 3 : UCIP_FA_2019_53347_20086.jpg

Comment Code						
Inspector Comment						
DS_ID:22969 FS_ID:53347 EP_NO: N/A Repair Type: Non-Urgent Crossing Status: Found UCIP Comments: 10/2/2018 Crossing shows no sign of pipe or levee integrity issues; down grading to Non-Urgent (D. Sanoski - DWR UCIP).11/29/2016 Flap gate appears to be either missing or broken. Pipes submerged on WS with concrete block on one pipe during inspection. No pipes found on LS. (K. Fazel - UCIP)03/29/2013 Pipe has broken flap gate. (P. Amatya - DWR) FIELD_STRUCT_DESC: 2 of 2: 36-inch corrugated metal gravity drainage pipe through the levee, approximately 18 feet below the crown. Pipe may not fully penetrate the levee as it does not daylight on the landside (LS). This drainage pipe was field discovered with no mention of it in any reference. FS Date: 10/2/2018 1:04:00 PM

WS- two CM pipes with damaged flap gates

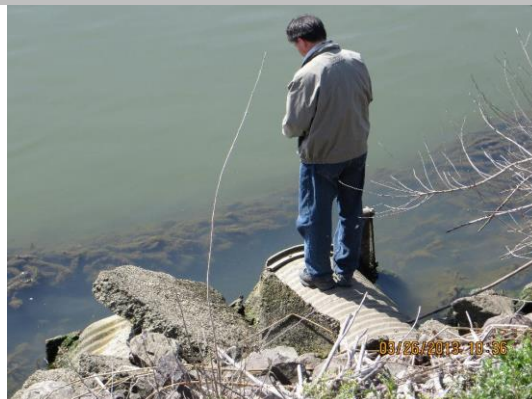
Photo 2 of 3 : UCIP_FA_2019_53347_20085.jpg

WS- right CM pipe with damaged flap gate

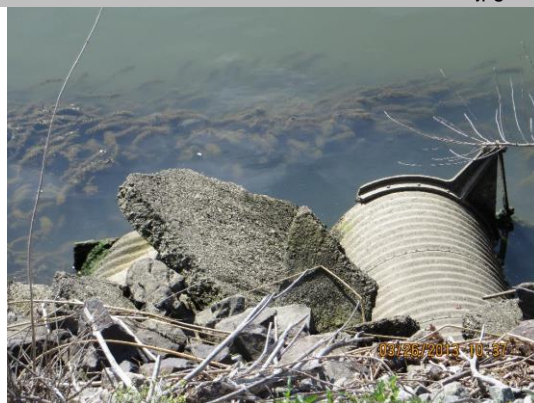
Photo 3 of 3 : UCIP_FA_2019_53347_20084.jpg

WS- closer view of right CM pipe with damaged flap gate

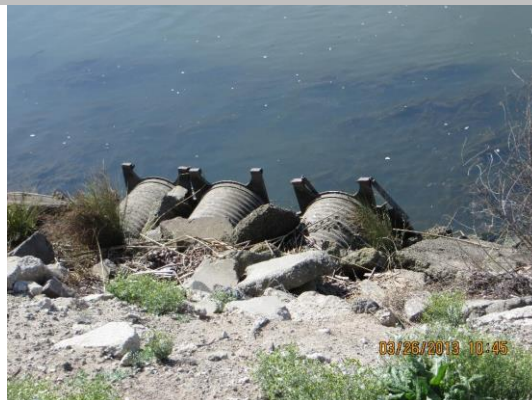
Photo 3 of 3 : UCIP_FA_2019_51168_20042.jpg

LM Start	0.65	Rating **	M	Issue No.	103 (cont)
LM End	0.65	Issue Type +	En	Location *

WS- CM pipes with damaged flap gates

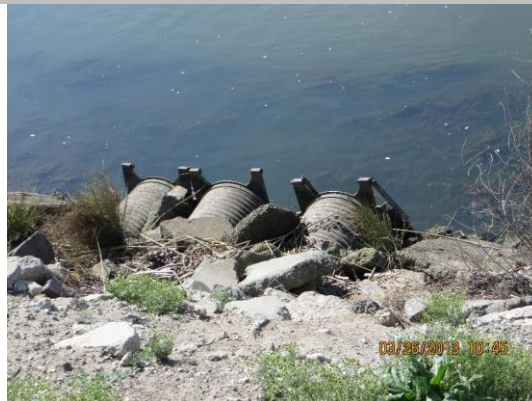
Photo 2 of 3 : UCIP_FA_2019_53348_20046.jpg

WS- CM pipes and damaged flap gates

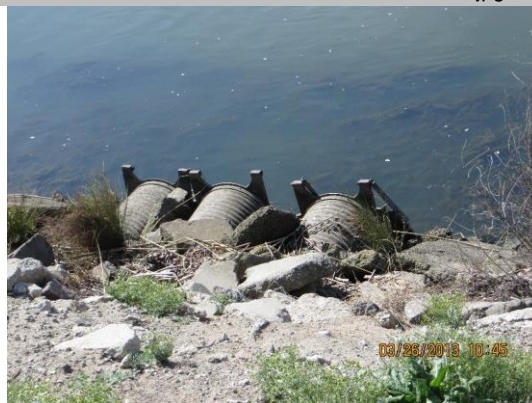
Photo 2 of 3 : UCIP_FA_2019_53349_20053.jpg

WS- CM pipes with damaged flap gates

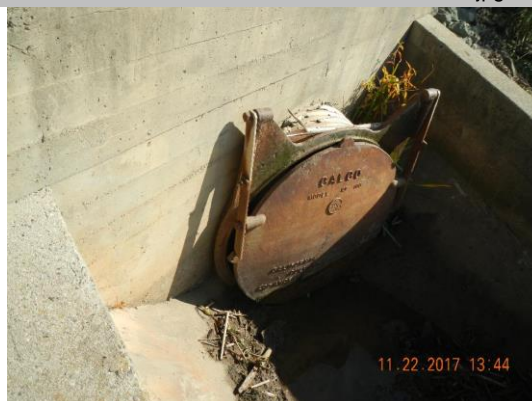
Photo 1 of 3 : UCIP_FA_2019_53532_77527.jpg

Comment Code						
Inspector Comment						
DS_ID:17945 FS_ID:53532 EP_NO: N/A Repair Type: No Action Needed Crossing Status: Found UCIP Comments: 11/22/2017 Received updated photo from DWR levee inspector D. Torres showing gate has been cleared of sediment to allow operation of the gate on the WS. Crossing has been downgraded from Urgent to No Action Needed based on the 2016 photos and the most current photo. Recommend coordinating with City of Stockton to determine as-builts, CVFPB permit, and date of last internal integrity inspection completed for this crossing. (DWR UCIP - O. Magana) 11/29/2016 Flap gate still buried with sediment on WS. Requires clearing. (K. Fazel - UCIP)03/26/2013 Partially buried flap gate (P. Amatya - DWR) FIELD_STRUCT_DESC: 42-inch corrugated metal drainage discharge pipe, 18 feet below the crown. Flap gate, concrete headwall, and spillway on the waterside (WS). Pump house on the landside (LS). Abandoned concrete headwall, power pole, and two wooden piles found on the LS. This drainage pipe likely belongs to the City of Stockton. [Additional Reference(s): DWR Levee Log, 2006. USACE San Joaquin O&M Manual 1, March 1963, (HLM 0.78)]. FS Date: 11/22/2017

WS view: WS gate cleared allowing proper operation of gate.

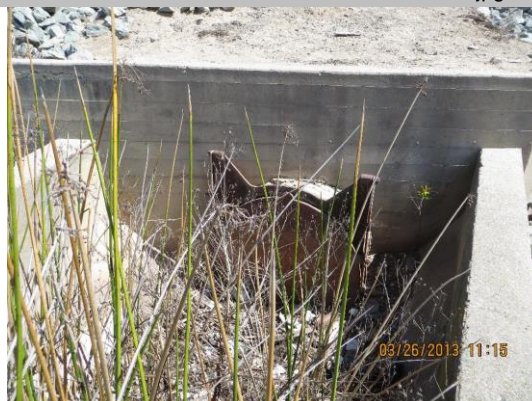
Photo 3 of 3 : UCIP_FA_2019_53532_19961.jpg

WS- Debris and vegetation blocking CM drainage pipe

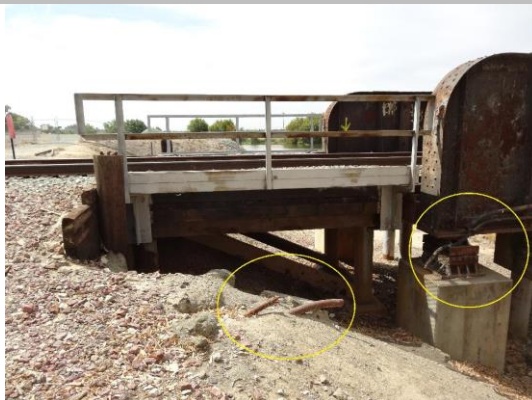
Photo 1 of 3 : UCIP_FA_2019_46810_74753.jpg

LM Start	0.79	Rating **	M	Issue No.	107
LM End	0.79	Issue Type +	En	Location *	
Category	Supplemental			GPS Latitude/Longitude	
				Start	End
Item	DRAFT DWR UCIP Field Study			37.937212°	37.937212°
				-121.333762°	-121.333762°
DWR ID	17946				
Comment Code					
Inspector Comment					
DS_ID:17946 FS_ID:46810 EP_NO: N/A Repair Type: Non-Urgent Crossing Status: Found UCIP Comments: Appears abandoned; if so should be done so properly. FIELD_STRUCT_DESC: Telephone conduit of an unknown size or material through both levees and under the San Joaquin River, at an unknown depth. This buried telephone cable is no longer operational. [Additional Reference(s): DWR Levee Log, 2006]. FS Date: 8/4/2015

WS view looking south: conduits penetrating levee slope now disconnected with those attached to bridge

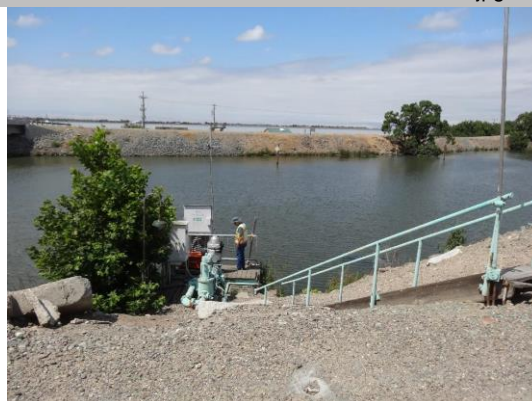
Photo 2 of 3 : UCIP_FA_2019_46801_74747.jpg

WS view: pump with shutoff valves, headwall, stairs visible. Concrete debris along WS slope.

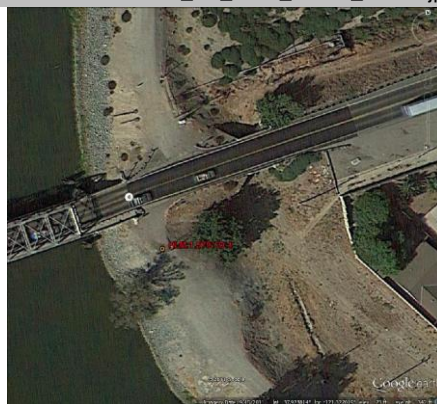
Photo 1 of 1 : UCIP_FA_2019_12386_20062.jpg

Aerial Photo @HLM=1.5791: No sign posts/markers found.

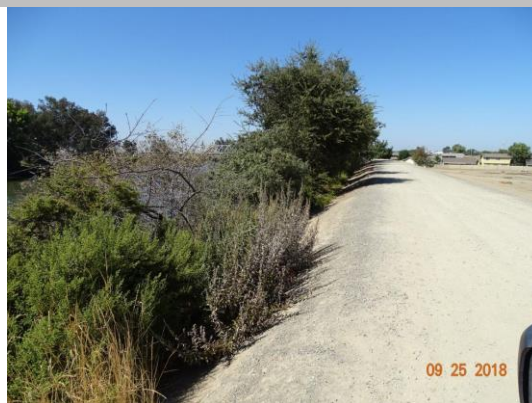
Photo 1 of 2 : FA_2019_RD0404_305_23_20190830_00009.jpg

Looking northwest at overgrown site on waterward slope. (Fall 2018)

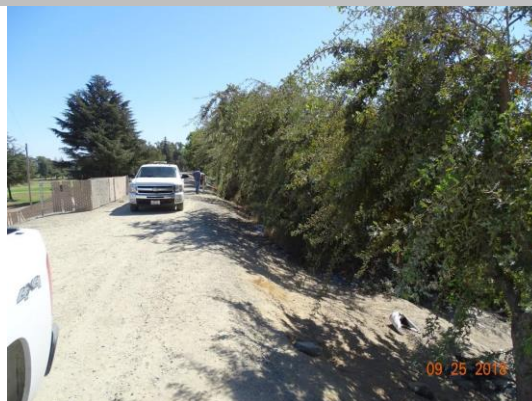
Photo 2 of 2 : FA_2019_RD0404_305_23_20190830_00010.jpg

LM Start	1.72	Rating **	A/W	Issue No.	23 (cont)
LM End	1.79	Issue Type +	Ob	Location *	WS

Looking southwest at overgrown site on waterward slope. (Fall 2018)

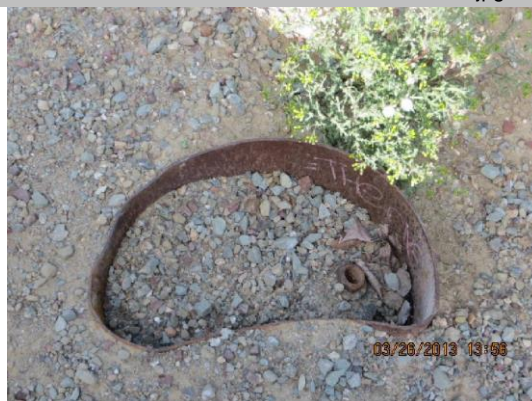
Photo 3 of 3 : UCIP_FA_2019_40797_20071.jpg

LS- damaged and obstructed siphon breaker on levee shoulder.

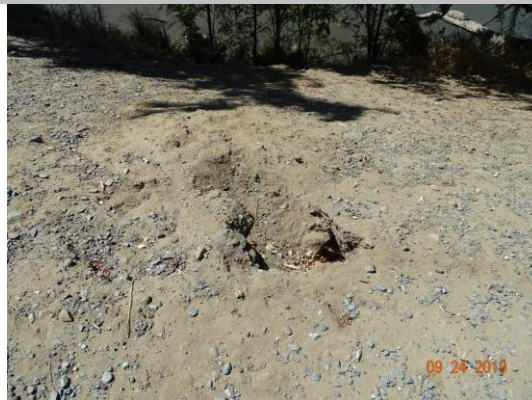
Photo 1 of 1 : FA_2019_RD0404_305_28_20191001_00054.jpg

View of multiple rodent holes on waterside slope. Fall 2019

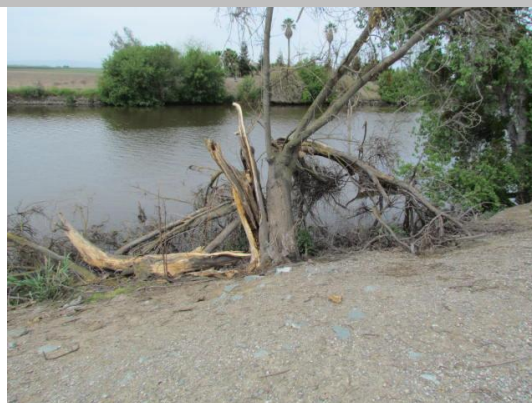
Photo 1 of 1 : FA_2019_RD0404_305_33_20190830_00014.jpg

Looking west at dead tree on waterward slope.

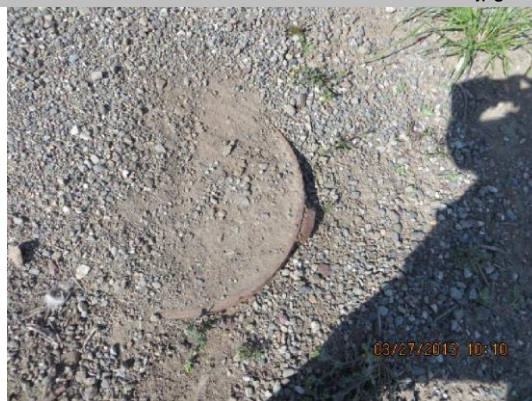
Photo 2 of 3 : UCIP_FA_2019_10908_18181.jpg

WS- damaged, obstructed and buried siphon breaker

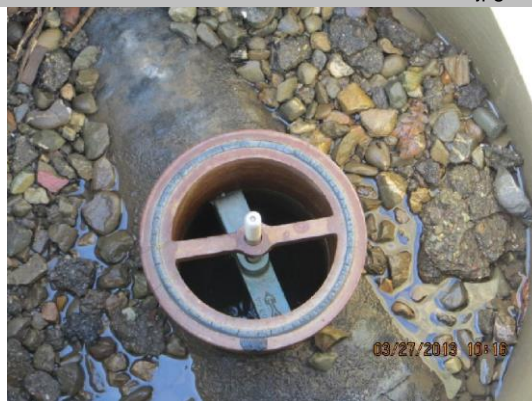
Photo 1 of 3 : UCIP_FA_2019_10945_18248.jpg

WS- siphon breaker without cap in concrete riser

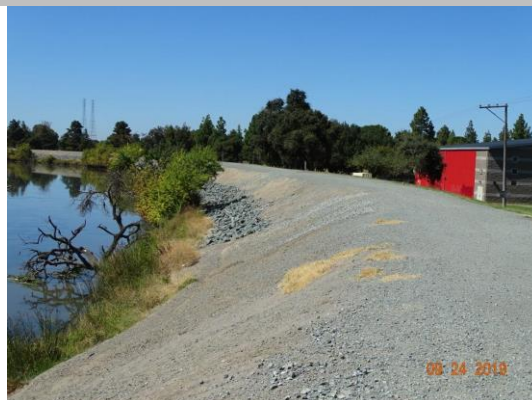
Photo 1 of 1 : FA_2019_RD0404_306_7_20191001_00027.jpg

Typical view of well maintained vegetation on waterside slope. Fall 2019

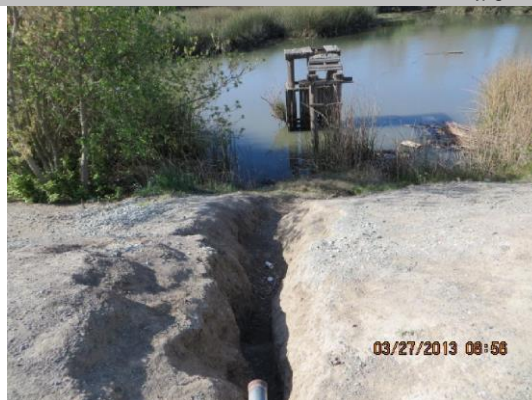
Photo 2 of 3 : UCIP_FA_2019_51171_18133.jpg

WS- soil erosion and gully formation due to leaky pipe
